**ALUMNI ROOFING**  
COMMERCIAL / INDUSTRIAL ROOFING

## Alumni Roofing Co., Inc. Roof Assessment & Repair Proposal

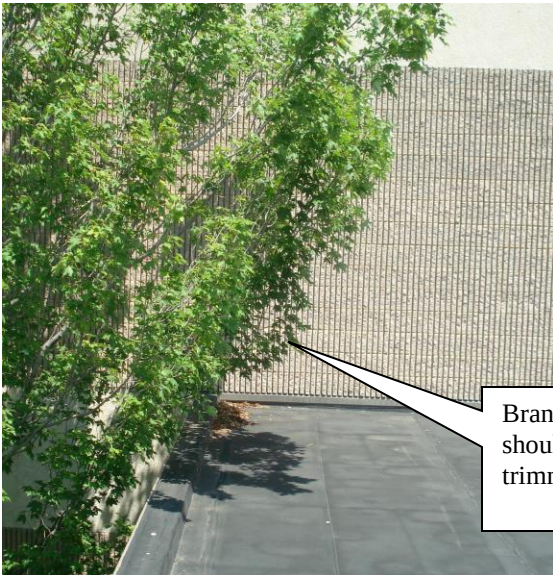
Branches  
should be  
trimmed

- Apply 6” cover tape over all field seams (approximately 6,000 linear feet)
- Apply cover tape over any curled patches
- Clean drains on Roof A
- Trim Branches on Roof A
- Remove rubber over any wet areas and replace with new insulation. Fully adhere new Carlisle rubber over the new insulation and seam to the existing membrane. This represents approximately 2,500 square feet
- Repair any holes in the wall flashing (especially Roof E)
- Repair a broken downspout along the back of the building
- Repair the entire expansion joint between Roofs B & F with new rubber
- Alumni will return this fall to perform a second thermal image of the roof system to insure no leaks or wet insulation
- Alumni will return up to 3 additional times over the next year to make any additional leak repairs at no additional cost.

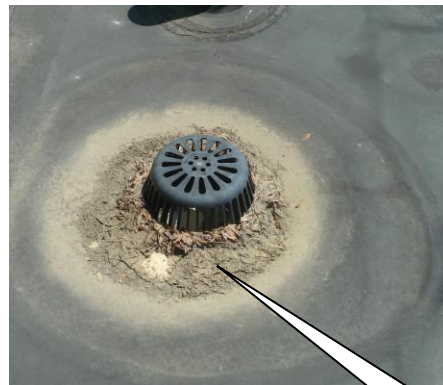
Drains need  
cleaned

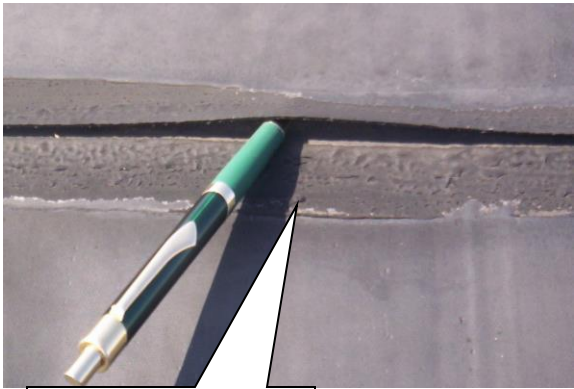
Typical field seam  
that is loose, but not  
leaking

The field seams are starting to lift / curl, and should have cover tape installed. In the winter water and ice will continue to cause the seams to lift

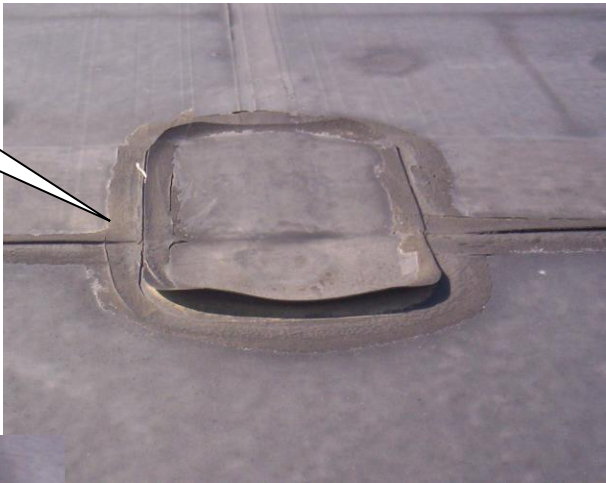
Curled patch that  
should be repaired

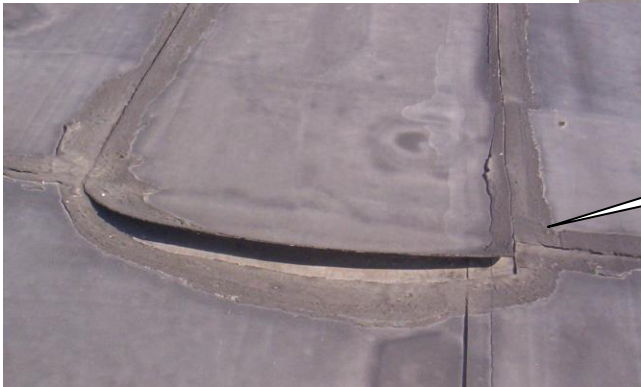
Curled patch

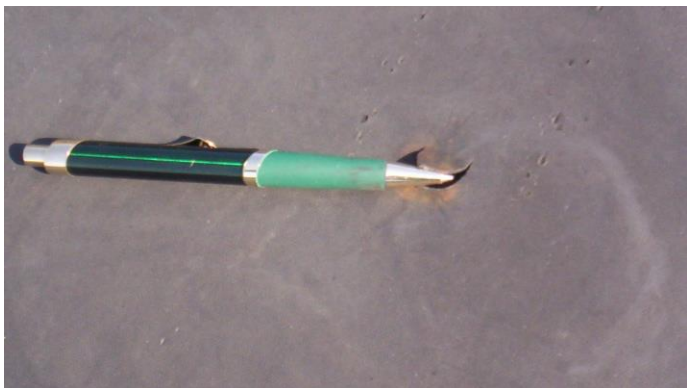
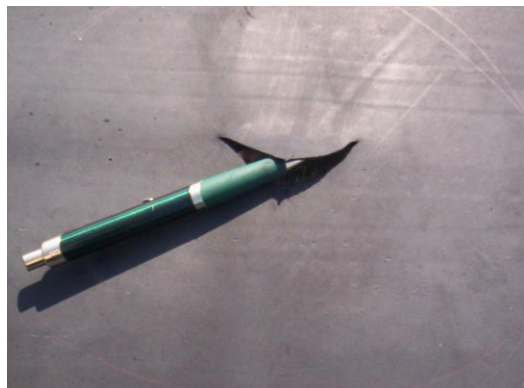
- The roof appears to be about 13-14 years old and is overall in good condition
- An exhaust fan hood has blown across the roof and caused several tears in the membrane. These holes have caused the insulation in several areas to become saturated (approximately 2,500 sf)

Roof B has  
approximately 10-12  
holes

It is our recommendation that the wet insulation be replaced prior to making any repairs. If the holes are patched without replacing the insulation, over time as the insulation dries it collapses and causes the insulation screws to poke through the rubber under snow loads. Also, the metal decking can begin to rust.

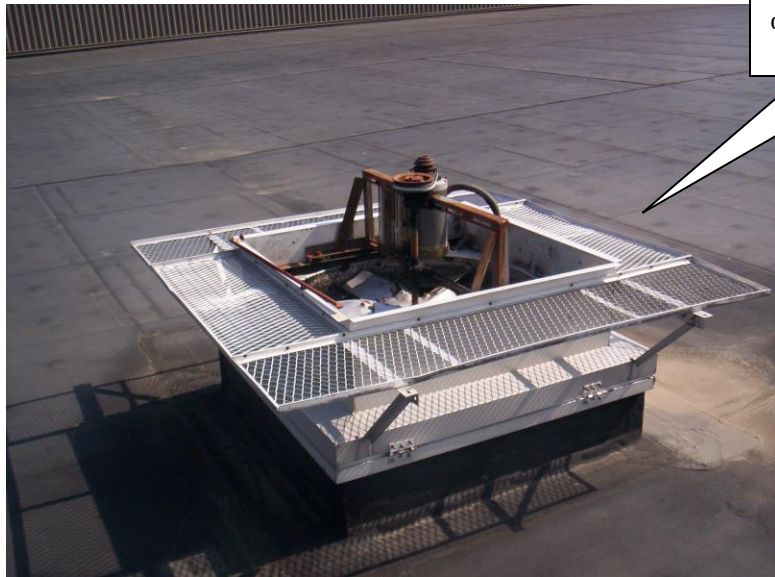
Vent hood blew across  
the roof and caused most  
of the holes

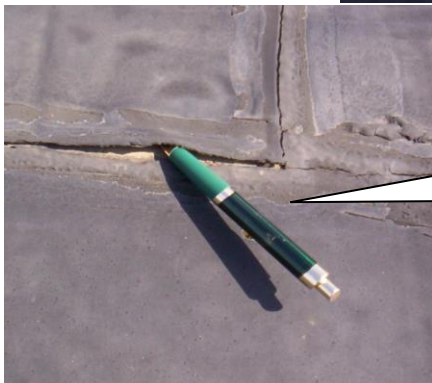
Typical loose, but  
not leaking field  
seam

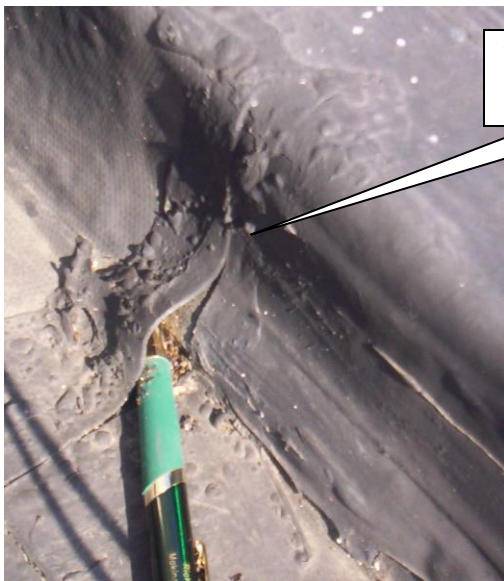
Wall flashing should be repaired

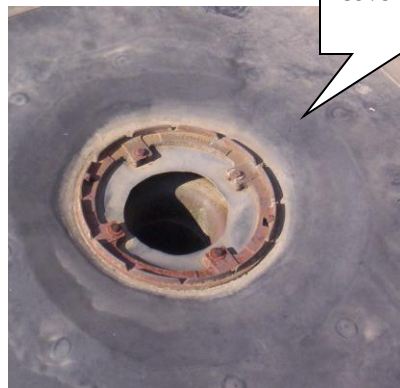
Missing drain cover

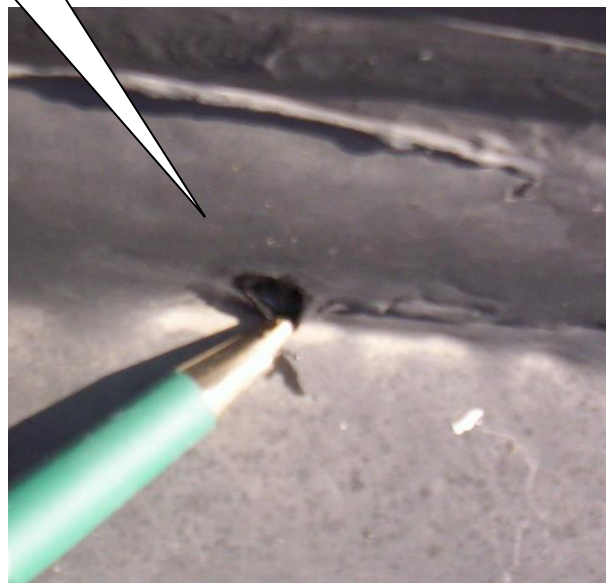
Hole in wall flashing should be repaired

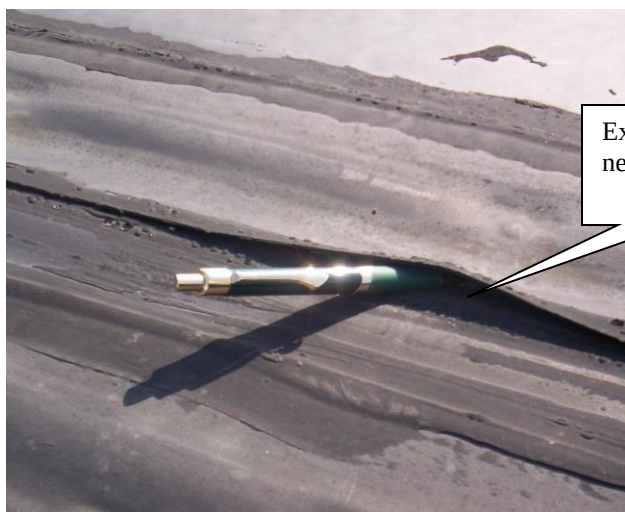
- The expansion joint between roofs B & E is in poor condition with several loose seams. Two 10 foot sections are currently leaking
- The metal siding around the second story in the back is in excellent condition

Expansion joint  
needs repaired

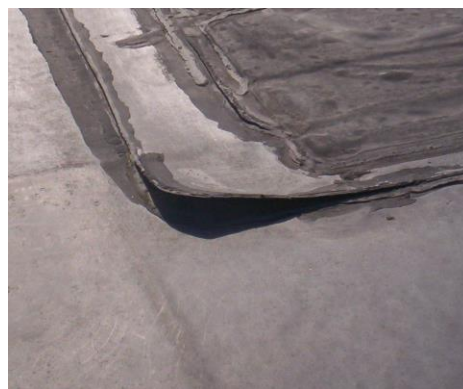
The culprit

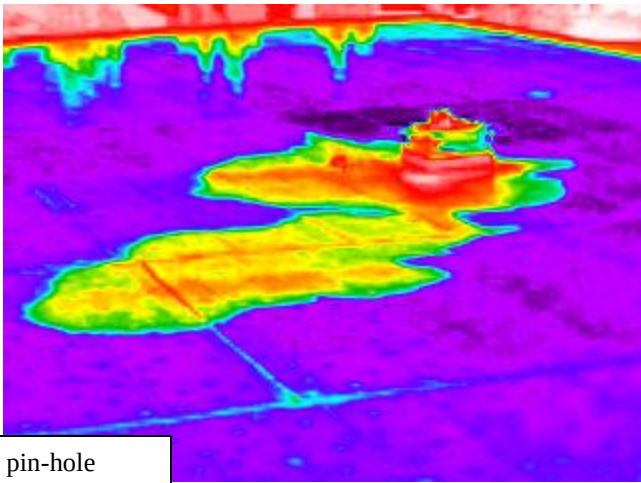
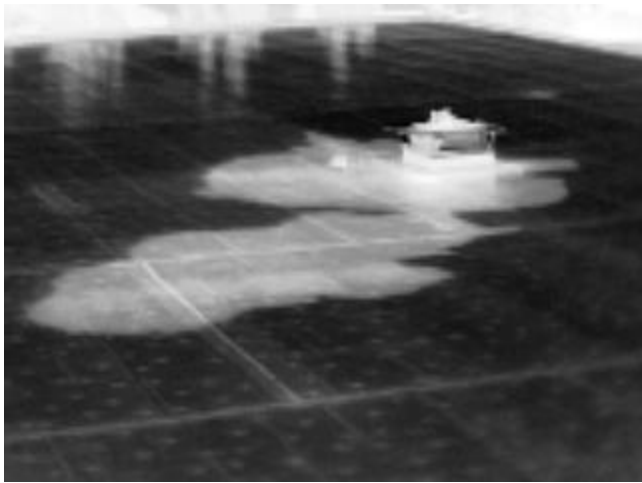
Significant moisture was found around one vent

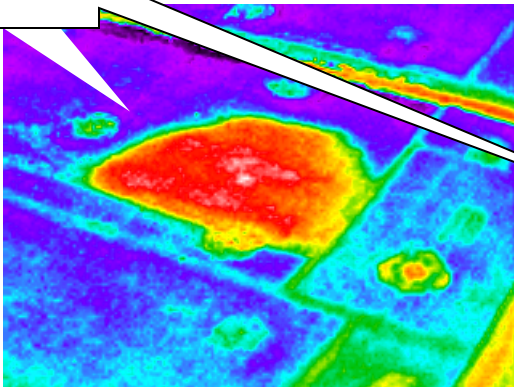
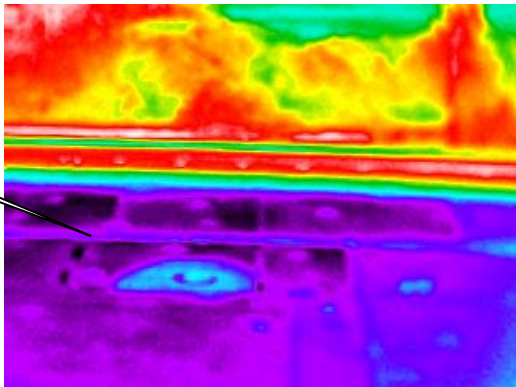
Two pin-hole leaks on Roof B

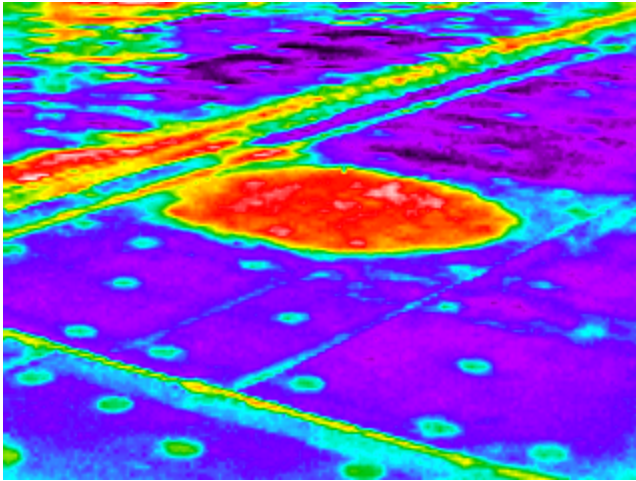
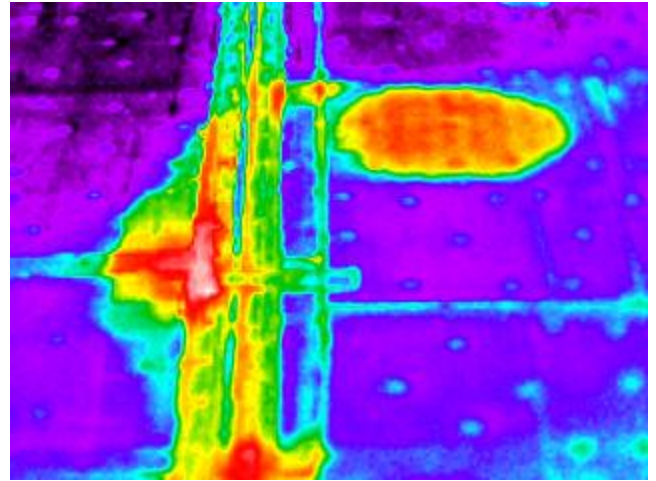
Expansion Joint between Roofs B & F

The expansion joint between Roofs B & F is leaking. All other leaks were caused by nickel / dime sized holes in the membrane. The field seams while showing their age are not leaking. No leaks were found around the drains or any other penetrations (vents / hatch, etc.)

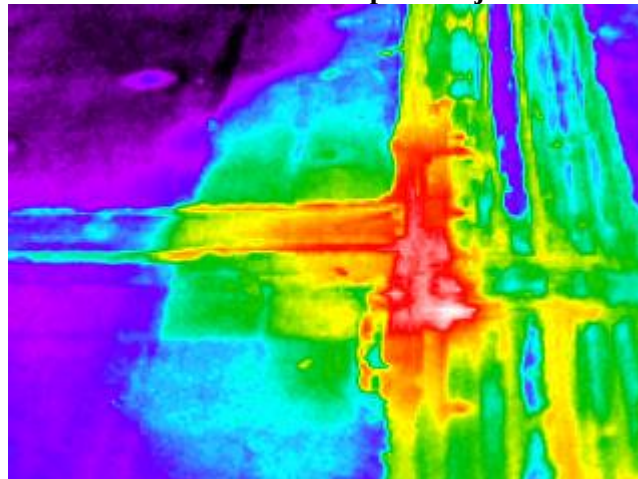
More around the expansion joint

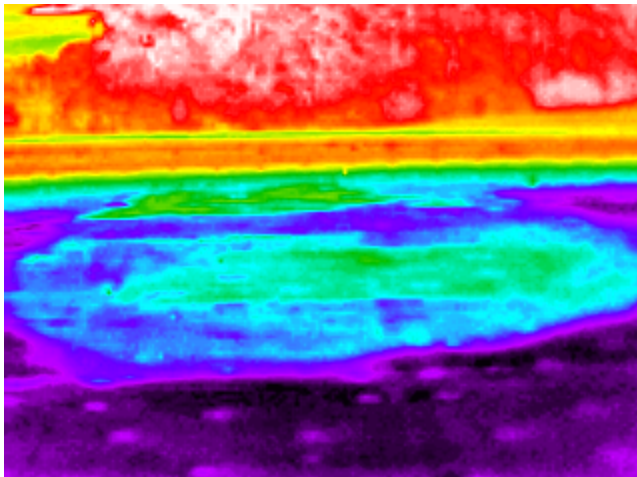
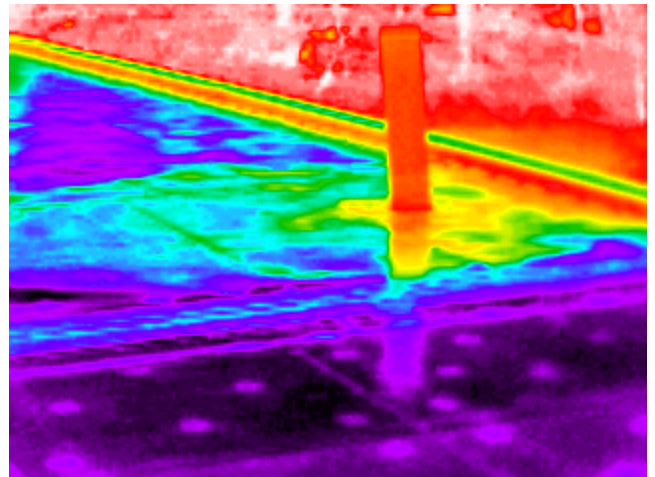
Two Leaks on Roof F

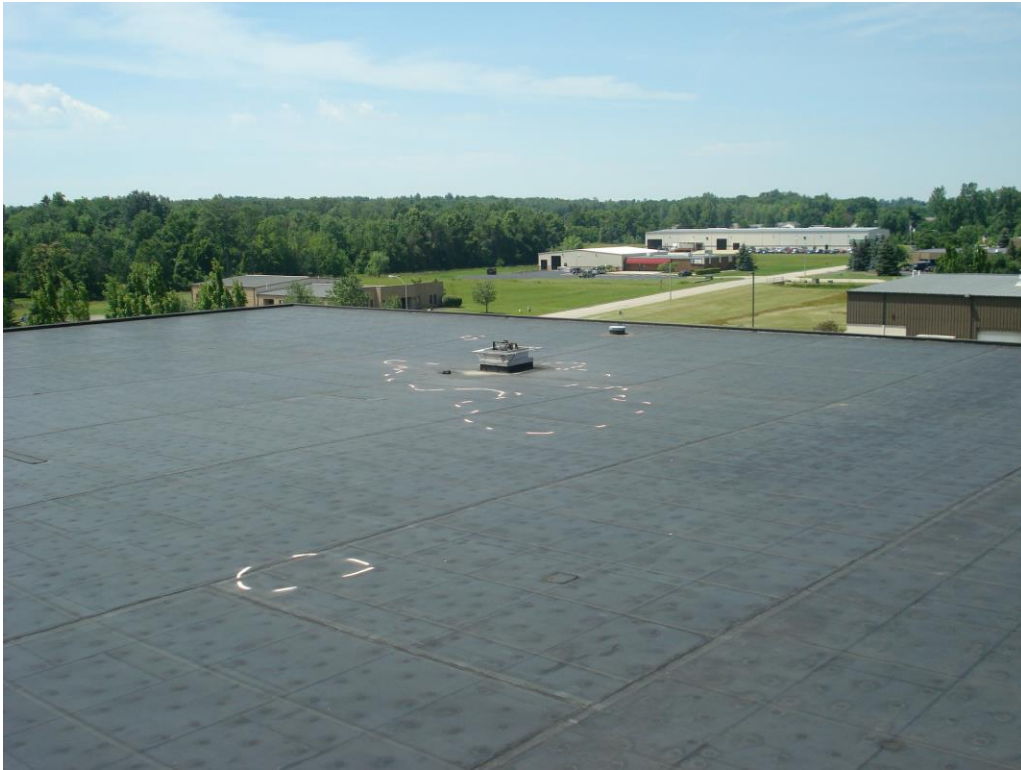
**Wet Areas  
Roof B**

Alumni scanned the roof and found six areas where the insulation was wet. Most of the wet areas were caused by small holes in the rubber caused when a vent hood blew across the roof. The holes have been present for some time and around each hole the area of wet insulation is from 50 to over 300 square feet.
